BMW

All models with petrol engine up to model year 11 | 2002

Engine backfires and loses power, engine control lamp lights up.

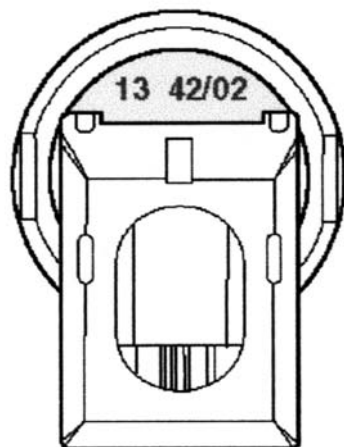
The date of manufacture is printed on the top of the ignition coil. The four last figures show the calendar week and year of manufacture.

All vehicles with ignition coils from Bremi are affected. To eliminate the fault, all ignition coils with a date of manufacture before 11/2002 must be replaced.
