BMW, all models with M52 engine

Hard starting with the engine warm

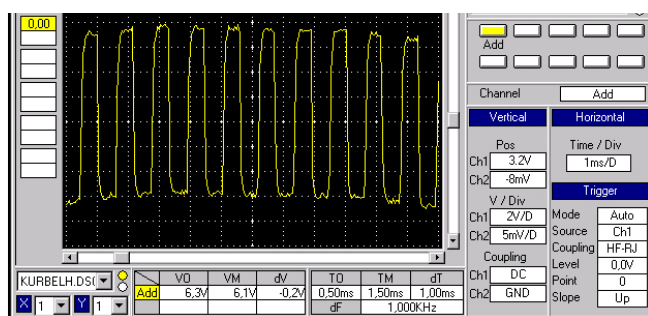
Camshaft sensor OK

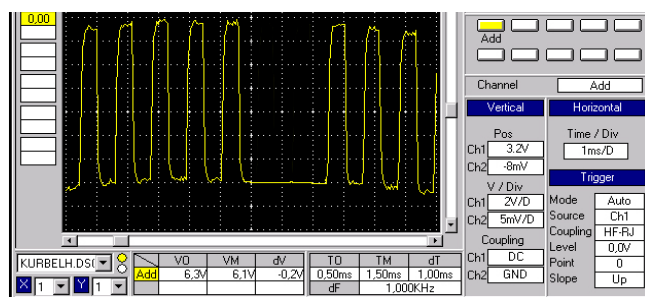
If there are complaints about the above-mentioned fault, the camshaft sensors could be responsible. The customer could also complain about a lack of power when starting from rest. In addition, the fault codes 18 (exhaust camshaft, implausible signal) and 65 (intake camshaft, implausible signal) are stored.

Camshaft sensor faulty

In this case the sensor signal images should be checked using an oscilloscope. Record the signal using a suitable diagnosis cable (see Fig. 1) or two suitable test prods. Evaluate the signal image (see illustrations below). If a signal image is faulty the respective sensor must be replaced.
