BULLETIN

Citroen C3 Pluriel (HB)

Water entering rear combination lamp

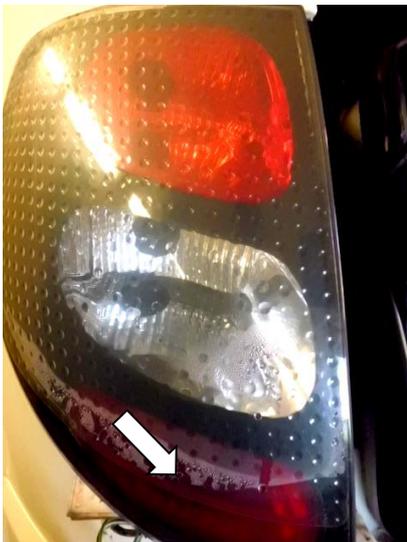
Figure 1

On the vehicles mentioned above, there is a risk of the rear combination lamp functions failing due to water ingress (Figure 1).

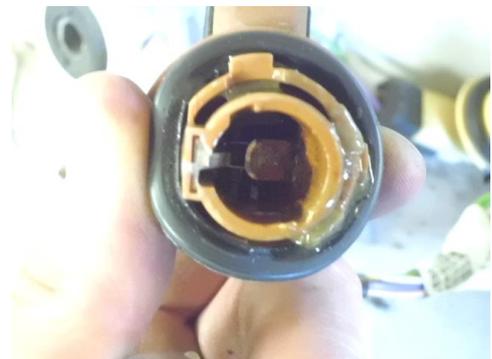
Figure 4

Then unclip the lamp at the side (Figure 3), remove and unscrew the bulb holders. Look out for contamination and corrosion (Figure 4).

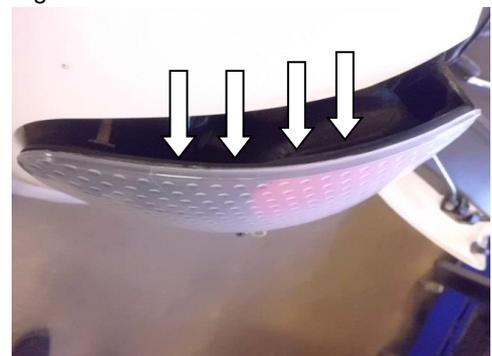
Figure 5

In most cases, the water ingress is due to a faulty welding seam on the plastic (above the lamp) (Figure 5).
