Citroën XM (Y4)

ABS warning light comes on/ ABS not working

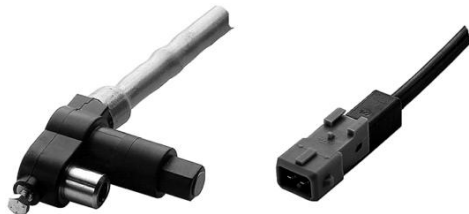
Hella ABS sensor front:

Part no.: 6PU 009 106-121

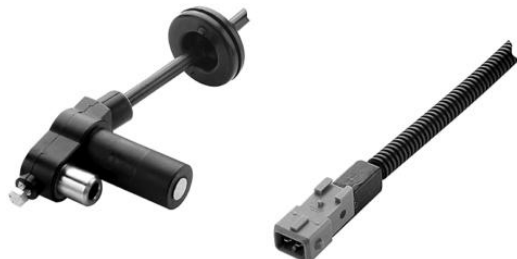
Hella ABS sensor rear:

Part no.: 6PU 009 106-131
