Renault Espace 2 (JIS63) with 2.0 ltr. petrol engine

Leaking refrigerant hoses

Bulletin

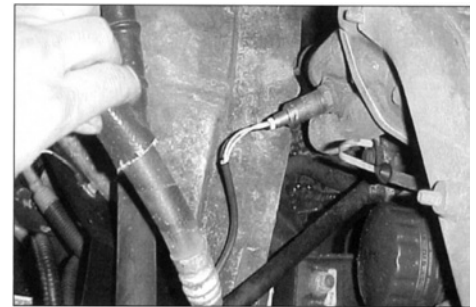
The refrigerant hoses on the above mentioned vehicles are exposed to the radiant heat of the engine due to their position. Over an extended period of time, this can cause the hoses to dry out and leak (see picture). The suction hose is particularly affected. In extreme cases the hose can burst.

For longer durability, the new hoses should be fixed as far away from the exhaust manifold as possible.
