## ***Fiat Multipla***

### **Leaking dryer connection**

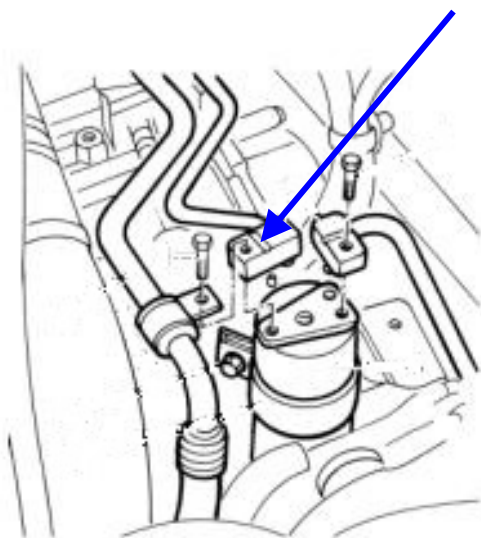
Fig. 1

With some of the above-mentioned vehicles there can be leaks at the fitting (Fig. 1) between the refrigerant pipe from the condenser to the dryer. The cause for this can be the guide of the fitting flange being 0.6 mm too long (Fig. 2). This prevents sufficient pressure being applied to the O-ring. The problem can be eliminated by shortening the guide.
