## **Fiat Stilo** **All models**

### **Water penetrating the headlamp.**

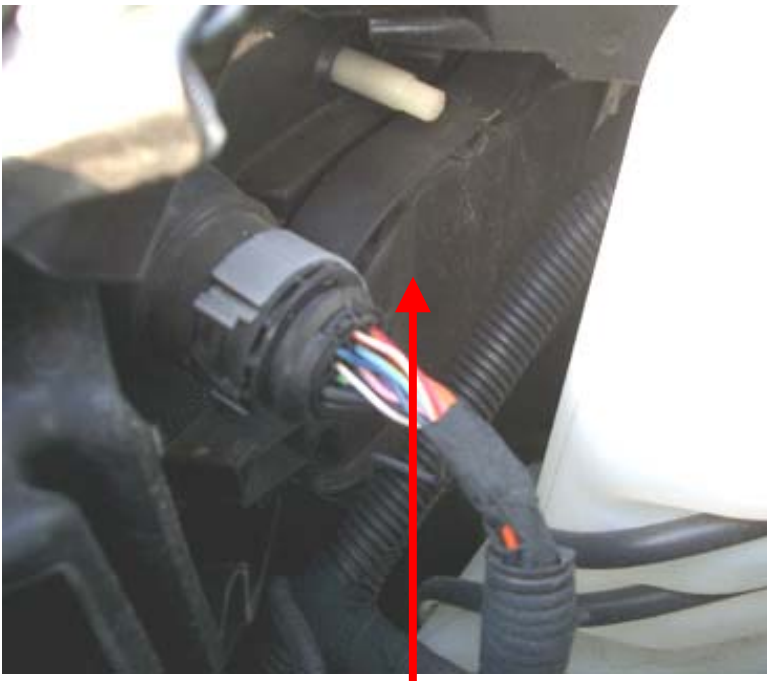
Cover for right-hand headlamp

If there are complaints about the formation of condensation in the headlamps, one possible cause is water penetrating the headlamp. In such cases, the complete headlamp(s) do(es) not have to be replaced. Only the rear cover has to be exchanged for a new modified version.

Even if the complaint only concerns one of the headlamps, the change should be carried out on both.
