Ford Escort buildyear 08/90

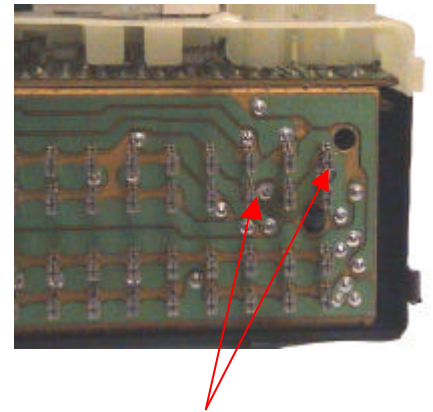
Some vehicle in the build range experience total heater fan loss. Due to this problem is a faulty soldering point in the fuse box.

During the voltage measurement at the fuse the ignition and heater fan should be switched on. If the heater fan is switched off, it is possible to measure a voltage in spite of the faulty soldering point. But this voltage can break off under load.

1. Be sure for the code number of the radio
2. Disconnect battery
3. Remove the lower instrument trim panel around the fuse box
4. notice the fuse number and ampere, remove fuses
5. Remove the front cover of the fuse box
6. After soldering the soldering point of the fuse holder from the heater fan fuse(fuse 15, exact details in the owner's manual)
7. Fit the parts in reverse order
