## **Ford Focus** **All models from 08.1998 – 04.1999**

### **Water penetration in the front footwell.**

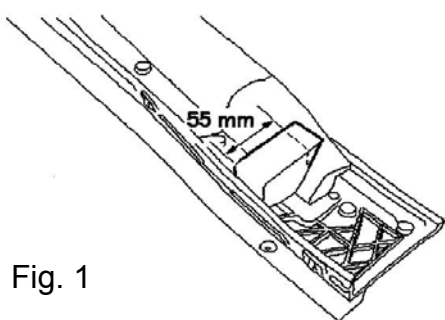
Fig. 1

If there are complaints with these vehicles about water penetrating the front footwell, one possible cause is poor sealing between the cowl grille and the windscreen. This affects the area above the interior filter. Water penetrates the poor sealing, gets into the interior filter and then into the vehicle interior. To eliminate the fault, a new cowl grille, which has to be reworked, has to be installed. To do this proceed as follows:

- Remove the old cowl grille.
- Check the interior filter and replace it if necessary.
- Rework the new cowl grille. To do this, shorten the foam block to 55 mm (Fig. 1). Drill an additional water drain hole (Fig. 2) and stick the extra butyl sealing strip to the cowl grille (Fig. 3).
- Install the new cowl grille.
