Ford Focus **Model year up to 20.06.00** **Model year up to 19.07.00**

Blower sometimes inoperative and perceptible smell of melting plastic

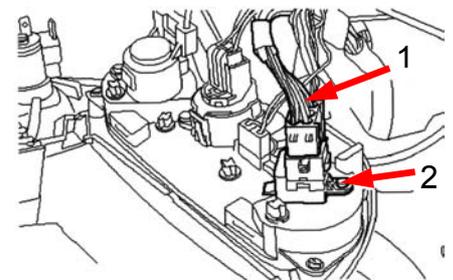
Fig. 2

If there are complaints about the above-mentioned faults, a poor electrical connector contact at the operating switch (blower motor) could be the cause. In extreme cases smoke can be observed coming from the lower part of the centre console. The high current consumption of the switch can lead to the connector melting.

In this case, a new connector must be soldered to the cable harness of the operating switch, and a modified operating switch must be installed.

- Remove the radio/cassette unit or CD player (see Fig. 1).
- Remove the bezel with the operating parts (blower, air conditioning, heating)
- Pull the connector off the operating switch 1 and remove the screws 2 (see Fig. 2).
- Install the new operating switch.
