Ford Ka with ABS built since 09/96

Problems with the radio when the ignition is switched on

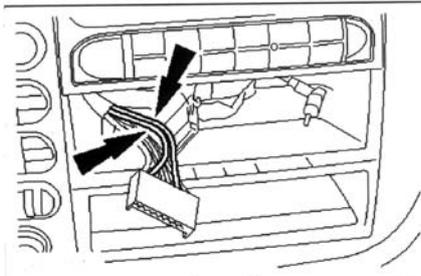
Fig. 1

If there are complaints with these vehicles that disturbing background noise is produced by the radio when the ignition is switched on, one possible cause is that the ground cable is too long. This is disturbed by the ABS module.

- Note the radio code and remove the radio.
- At the plug for voltage and ground supply, cut off the black/yellow wire from Pin 2 and the black/green wire from Pin 6 approx. 5 cm away from the plug (Fig. 1).
- Insulate the cable ends and attach to the cable harness.
- Solder the new ground cable (brown 2.5 mm², 400 mm long) to the black/yellow and black/green cable. Insulate the solder spot.
- Remove the upper and lower steering wheel skirt.
- Lay the new ground cable from the radio plug to the cross member of the steering wheel column.
- Attach the connection eyelet (M 6) to the new ground cable.
- Fix the ground cable to the screw on the cross-member (Fig. 2).
- Install the components again in reverse order.
