Bulletin

Ford Maverick 2.0L / 3.0L Engine code: YF / AJ Model year: 2001–2002

Engine not running smoothly Engine control lamp (Mil) lit.

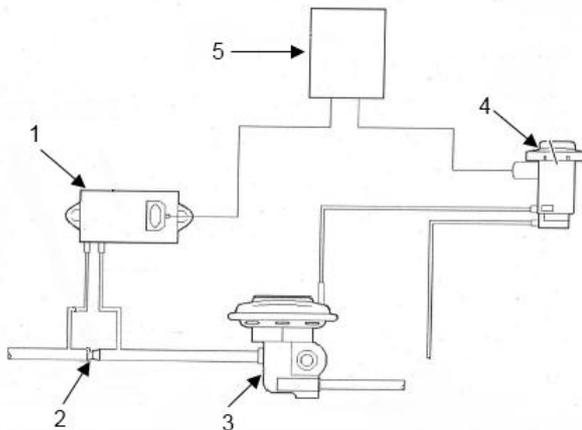
Fig. 1

- Pos. 1 = Differential pressure sensor
- Pos. 2 = Differential pressure measuring point
- Pos. 3 = EGR valve
- Pos. 4 = Exhaust gas recirculation solenoid valve
- Pos. 5 = Engine control unit

The measured values of the exhaust gas return rate are measured by the differential pressure sensor at the differential pressure measuring point (see Fig. 1). These values are forwarded as a voltage signal to the engine control unit. A technical fault could bring about an erroneous measurement of the amount of exhaust gas actually recirculated.

First of all, the pneumatic EGR valve is to be checked.
If no fault is found here, the differential pressure sensor should be regarded as a possible source of the trouble.
