Ford Mondeo III Model year from 2000 to 2004 All vehicles with xenon light

Failure of the xenon headlight

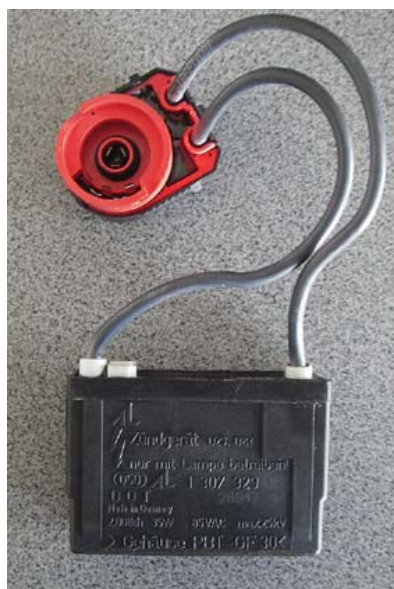
Fig. 1

If there are complaints about the above-mentioned fault, a defective ignition module could be the cause. Failure is sporadic, but is found with increasing frequency when cold-starting a vehicle. In this case, the ignition module must be replaced. Therefore, the manufacturer offers a conversion kit with a new generation of ignition modules.

- Disconnect the battery.
- Remove the headlight and unscrew the rear headlight cover. (See Bulletin "Ford Mondeo replacement of the light source").
- Remove the contact plug from the xenon bulb, and unscrew the old ignition module (see Fig. 1) from the headlight.
- Loosen the fastening ring of the xenon bulb, and afterwards refasten the bulb with the modified ring.
- Plug the new ignition module (see Fig. 2, Item 1) onto the xenon bulb, and turn it to the right to fasten it.
- Connect the adapter cable (see Fig. 2, Item 2) to the power supply cable of the old ignition module.
- After that, plug the contact plug (see Fig. 2, Item 3) into the new ignition module.
- Refit the headlight cover and all other removed parts in reverse order.
