Ford ***Type: Probe; Explorer, Windstar.***

Refilling additional coolant oil for models older than 1996 - compressor failure

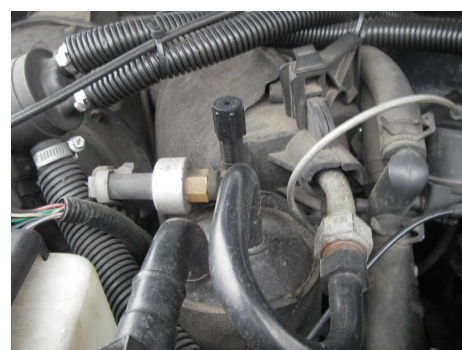
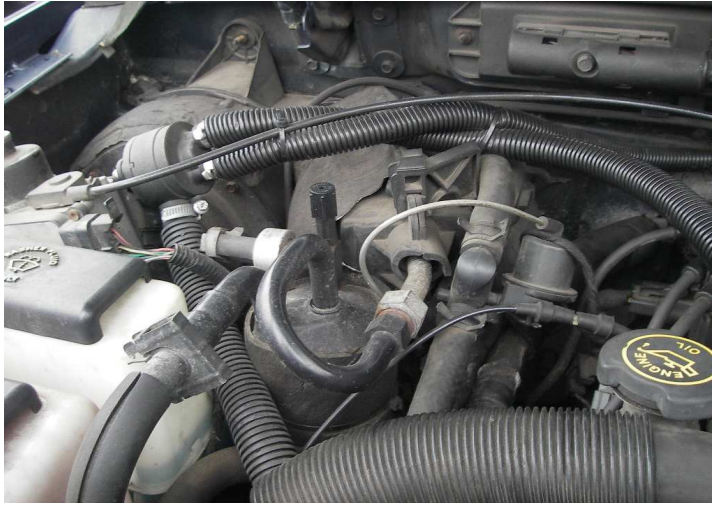
Ford recommends e.g., refilling approx. 60 ml of oil during maintenance or minor repairs on the original air conditioning system. This quantity must be added before the system is filled with coolant. Ford's R134a systems can be distinguished from R12 systems by a special sticker on the underside of the motor hood and a beige-coloured ring on the low-pressure switch (see figures).
