## **Hyundai Atos 1.0-litre Engine code G4HC All vehicles until model year 12.99**

### **Engine runs roughly**

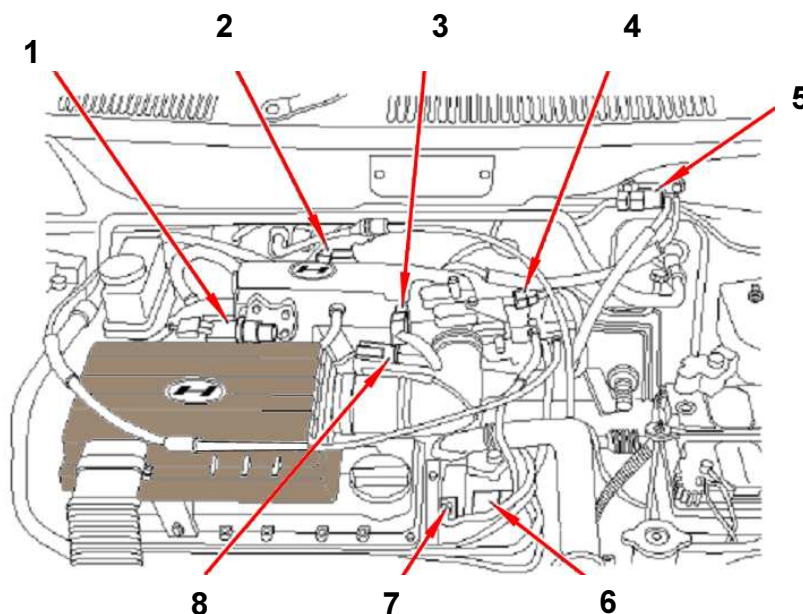
If there are complaints about the above-mentioned fault, the cause could be a defective wiring harness. Further complaints may be:

- No engine power
- Delayed throttle response
- Engine cuts out when driving

In these cases, the wiring harness and the plug-contacts and plug-connections to the intake pressure sensor, the distributor and the throttle-blade switch should be checked for damage and, if necessary, repaired.

It should also be ensured that the cables are laid in such a way that no tension load can arise on the plug-connections, e.g. through engine vibrations.
