BULLETIN

Jaguar

Insufficient cooling from air-conditioning system

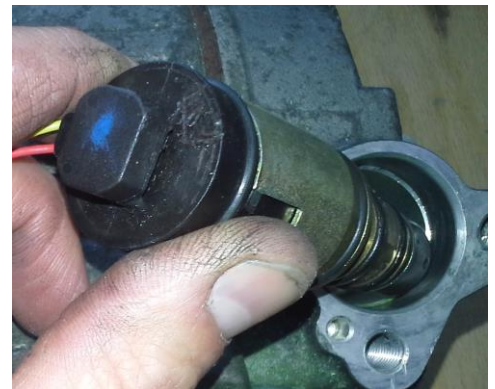
If the customer complains that the cooling power of the air-conditioning system in one of the aforementioned vehicles is insufficient, this may be due to a faulty pressure control valve in the compressor.

A faulty pressure control valve can often be identified by unusual high and low pressure: high pressure too low; low pressure too high.

The figure shows an example of an electronically actuated pressure control valve

- Drain off refrigerant
- Remove compressor (usually required)
- Clean area around control valve
- Remove circlip from valve
- Carefully remove control valve
- Check the area of the compressor into which the new valve is going to be inserted for damage and soiling
- Moisten the seal rings on the new valve with compressor oil, and insert the new control valve
- Fit circlip
- Fit compressor
- Carry out leak test
- Fill air-conditioning system and perform a functional test
