# BULLETIN

## **Mazda 6 (GG/GY) Model year: 2002 - 2008 Engine: 2.0 Di**

### **Compressor malfunction**

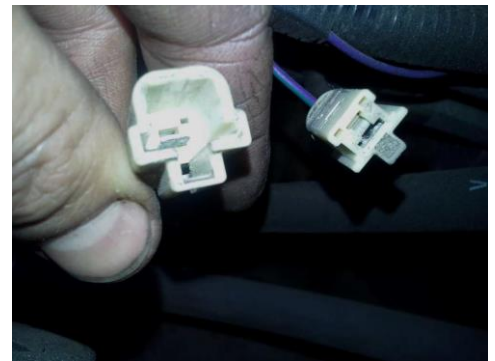
The electrical cable for the magnetic clutch power supply (+) is routed to the compressor through the engine block area.

Water leaking into the connector housing (figure) can cause corrosion to form. This can lead to contact problems or a power failure.

In order to remedy this issue, the damaged electrical connection should be renewed.
