## *Mazda MX-5 (Typ: NA+NB)*

### Ignition wire

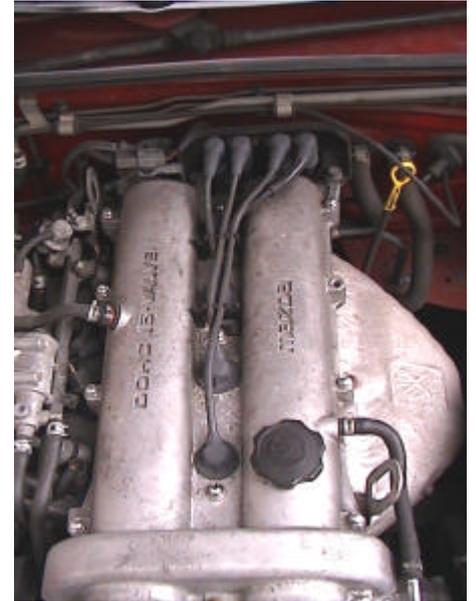
The ignition wires directly fixed to the engine block, are often the cause of the following faults:

Over time the insulation of the ignition wires becomes porous due to the high thermal radiation. The consequences are current leakage and spark arcing between ignition wires and the engine block. Because the MX 5 has a distributor less ignition system and one coil provides two spark plugs with the necessary energy, the condition of the ignition wires is very important. Worth mentioning is also, that every ignition pulse must flow through to both wires simultaneously. One of them is redundant because it sparks when the cylinder is not approaching the power stroke of its cycle.

Use only high quality silicon ignition wires. It is also recommended to check the spark plugs and the contacts of the ignition coil. Should the contacts appear black or grey, they must be cleaned. The ignition coil should then be checked as well.
