Mercedes Benz C-Class (W 203)

Failure of the front direction indicators.

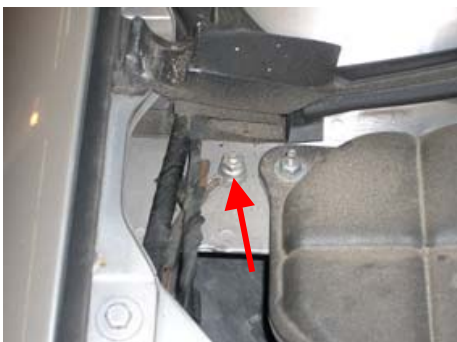
Earth point right

If there are complaints with this vehicle that the front right or left direction indicator is not working, one possible cause is a charred contact in the direction indicator bulb holder.

To eliminate the fault, a direction indicator bulb holder including cable assembly has to be installed. To do this, proceed as follows:

- Remove the direction indicator bulb holder from the headlamp housing.
- Pull the connection plug off the headlamp.
- Remove the indicator connection lead on the vehicle side from the plug (right-hand side – pin 1 green/black cable, left-hand side – pin 1 white/black cable). Close the opening in the plug using a dummy.
- Insert the connection lead into the repair plug for the direction indicator. Connect the earth cable to the earth point on the vehicle (see photo).
- Lay the new cable harness for the indicator bulb holder and fix in place using cable ties.
- Insert the direction indicator into the headlamp housing.
- Check function.
