Bulletin

Mercedes Benz A-Class, Type: W 168 Model year: 1997 to 2004 All models

Uneven or increased wear on disc brake pads Thermal overload

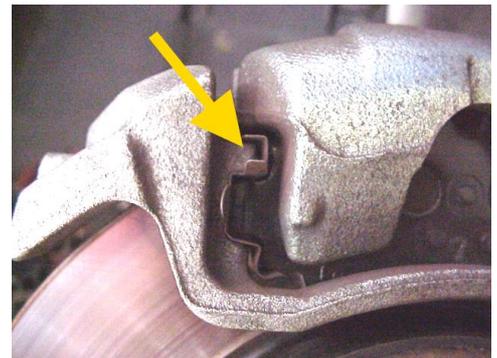
Seized up brakes and uneven or increased wear of the brake pads are frequent problems with brake systems that have Nirosta guide plates. One cause of this is dirt and corrosion which can accumulate below the plate (see picture). The result is that the guide plates curve upwards and then jam the brake pads.

The lack of free movement for the brake pads leads to thermal overload if the brakes are applied or not.

When maintenance work is carried out on the wheel brake, the contact surfaces on the calliper bracket have to be cleaned of dirt and corrosion and treated with corrosion protection. The guide plates also have to be greased.

We recommend using HELLA PAGID metal-free permanent lubricant for this. (8DX 355 370-011)
