# BULLETIN

## Mercedes Benz Model series 211, 219 and 230 All models with electro-hydraulic brake system Sensotronic Brake Control (SBC)

**Message on instrument cluster:  
"Reduced brake power/increased braking  
distance! Start engine!"  
No error code issued in the control unit**

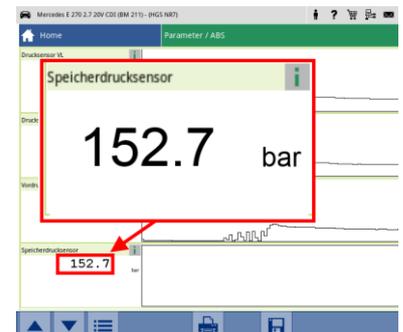
If the above error message is displayed after a longer vehicle downtime period, this may be due to a leak inside the SBC hydraulic unit. The SBC pump may also start up more frequently without the brake being actuated.

- Connect the diagnostic unit
- Start the engine
- Press the brake pedal repeatedly to increase the pressure in the pressure accumulator
- Read off the actual values/parameters (illustration)
  - Pressure accumulator approx. 150 bar
- Read off the pressure in the pressure accumulator after 15, 30, 45 and 60 minutes

If the pressure drops by more than 7 bar within 60 minutes, the SBC hydraulic unit needs replacing.
