Mercedes Benz C Class (W 203)

Indicator not working

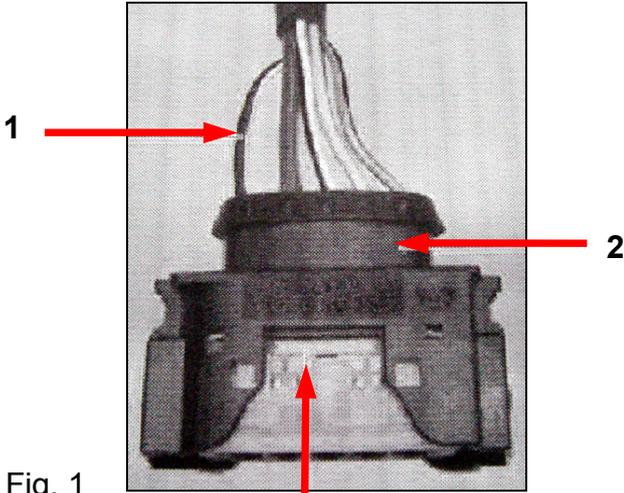
Fig. 1

If there are complaints about the above-mentioned fault, the cause could be contact problems. High contact resistances are caused due to the contact pressure between the bulb socket and the headlight being too low. These lead to overheating, and the contacts burn. In this case, a new harness, which is offered by the manufacturer, must be installed. Proceed as follows:

- Using suitable tool, release the lock of the plug-contact of the supply cable (see Fig. 1, Item 1), and remove from the central plug (see Fig. 1, Item 2). Colours of the supply cable:
right: black/green
left: black/white

- **Caution!** In the case of some plugs, the fastening clamp for all contacts must be unlocked first (see Fig. 1, Item 3).
- Close the open slot using the blind plug.
