## **Mercedes-Benz C-Class (W203) From model year 08/01**

### **ESP warning light comes on, fault code C1140 and/or C1145 in the fault memory.**

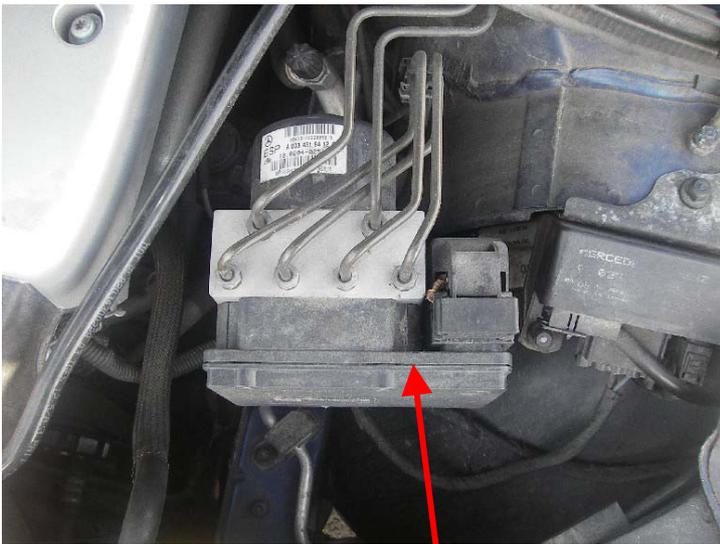
Fig. 1 ESP unit

If there are complaints with these vehicles that the ESP warning light comes on and the fault code C1140 and/or C1145 is stored in the fault memory, one possible cause is contact resistance in the plug on the ESP control unit (Fig 1). This affects the connection between the ESP control unit and the brake pressure sensor. To eliminate the fault, the plug contacts 18, 19 and 20 must be replaced in the control unit plug and the control unit contacts must be cleaned. To do this proceed as follows:
