## Mercedes Benz C-Class (W203)

### Brief sporadic illumination of the headlights

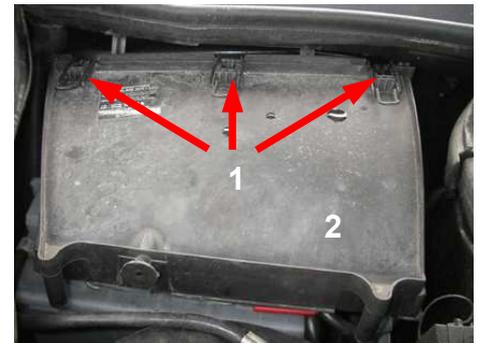
Fig. 1

If there are complaints about the above-mentioned fault, the cause could be a malfunction in the control unit signal recording and control module (SAM). In order to eliminate the fault, proceed as follows:

- Remove the dust-filter housing. The dust-filter housing is located under the bonnet, front right
- Undo the snap fastenings (see Fig. 1, Point 1) and take out the dust-filter housing (see Fig. 1, Point 2).
- Disconnect the earth terminal from the battery and leave it disconnected for 15 minutes (see Fig. 2).
- After that, refasten the terminal to the earth pole.
- Check the operation of the headlights. To do this, carry out a test drive during darkness.
