## **Mercedes Type: 203**

### **Exterior lighting and/or stop light switch on of their own accord**

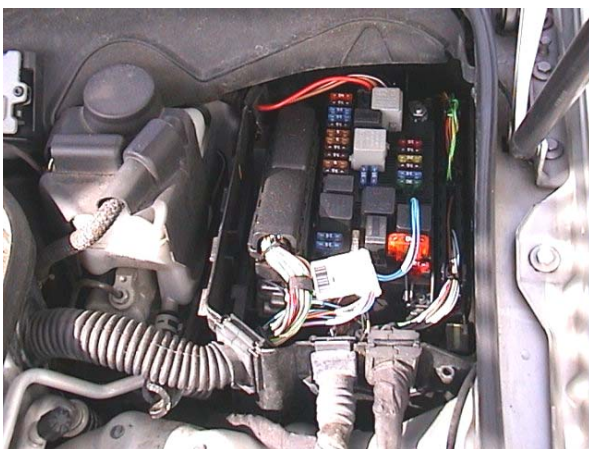
Water penetrating the module box (photo, engine compartment - left) can lead to problems with the signal recording and control module (SAM, N10/1). These problems are noticed by the fact that the exterior lighting and/or stop light switch on of their own accord. To resolve the problem proceed as follows:

- Take the lid off the module box and remove water residues
- Loosen the wiring harnesses from the module box
- Check the module box, leads and control units for water residues and dry if necessary
- Wrap about 10 cm of insulating tape around the wiring harnesses, and insert the wiring harnesses into the cable grommets again
- Fix the wiring harnesses with cable ties and
- Refit the lid of the module box
