## Mercedes Benz Vito (Type 638)

### Stoplight not working

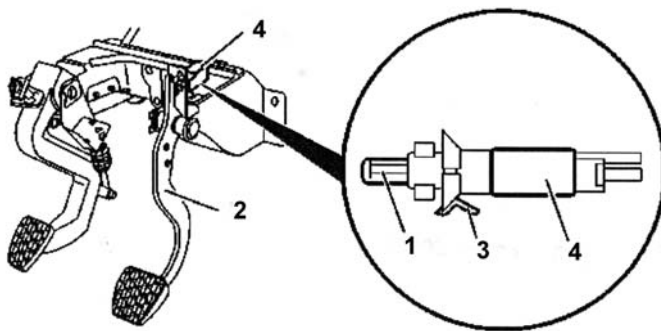
If there are complaints about the above-mentioned fault, an incorrectly set stoplight switch could be the possible cause.

- Remove the cover under the steering wheel (footwell).
- Press the brake pedal.
- Pull the stoplight switch operating pin out fully.
- The correct operating pin path is now set automatically.
- Check function.
- Refit the cover.
