Opel Astra G, Zafira, Vectra B All models from model year 1998

Airbag warning light illuminates

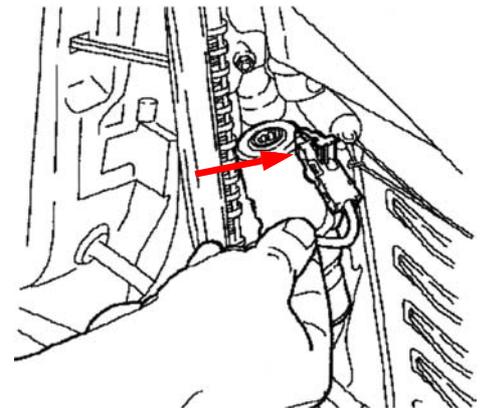
Fig. 1

If there are complaints about the above fault, poor contacting in the restraint system (seat belt tensioner) connector could be the cause. In this case, the cable ends must be connected with one another.

- Disconnect the battery and wait for one minute until the capacitor has discharged.
- Remove the backrest cover on the front seats.
- Unlock the connector for the side airbag and for the restraint system from the bracket (see Fig.1).
- Separate the connection.
- Remove insulation tape from the cable assemblies over a length of approx. 2 cm.
- Cut the cable connector from the airbag cable assembly and strip the ends approx. 10 mm. Carry out the same working steps with the cable assembly of the restraint system.
- Connect the respective cable ends with the aid of ~~CWT solder muffs~~ **self soldering joints** (Hella part no.: 8KW 744 888-003). Make sure that the cables do not get mixed up.
- Insulate the cable loom and place it back in the grooved tube.
