Opel Astra H Model years: 2004 - With air-conditioning system

Noise from the engine compartment

Bulletin

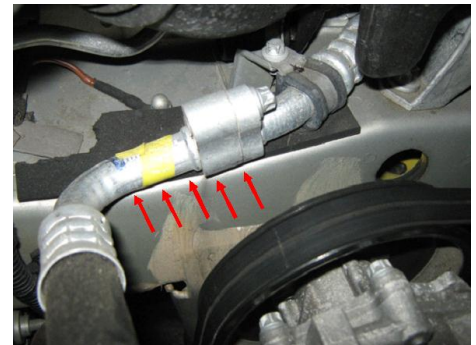
Noise may be coming from the engine compartment in the above vehicles when the engine is running at operating temperature. This occurs in particular during acceleration of the vehicle and an engine speed between 2000 and 3000 rpm.

The cause may be a missing or misplaced damper strip between the frame rail and the refrigerant line (see image).

Make sure that the damping strip is present and correctly installed. If necessary, attach a new damping strip. When doing so, make sure that the refrigerant line does not come into contact with the frame rail.

Otherwise, the flow noise of the refrigerant may be transmitted through the body into the vehicle interior. It is important to ensure that the damping strip extends approx. 5 mm beyond the edge of the frame rail.

Note: A suitable damping strip is Hella part no. 9MJ 351 018-011
