BULLETIN

Vauxhall Astra J GTC Model year: 2012 Chassis number_ CG000001 – CG107856

Noise in the roof lining area

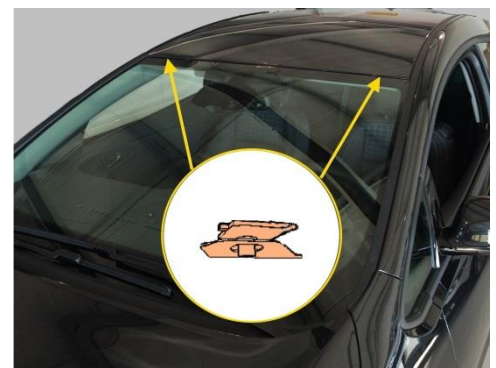
Figure 1

The cause of this noise development could be the clips that were used as a mounting aid for the panorama windshield (figure 1).

The clips may come loose due to heat generation (insolation) for example.
