## *Opel Astra-G 98 - 2000* *Zafira 99 - 2000*

Leak between the lens and housing of the headlamp.

Bulletin

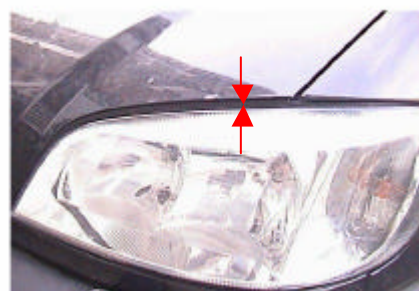
Picture 1

If the problem is dew in the headlamp, on the above mentioned vehicle, the fault can be attributed to a too small gap between the bonnet and headlamp (Pic.1), this causes the bonnet to knock or press onto the headlamp and it becomes damaged.

To rectify the problem one or both faulty headlamps must be renewed. Additionally the following work must be carried out:

Check the newly adjusted gap between the bonnet and the rubber seal of the headlamp. Use a 0,5 mm thickness gauge. It must slide through the gap without any resistance.
