Opel Corsa-C Buildyear 2001-2002 All models

Water ingress in the left front foot well.

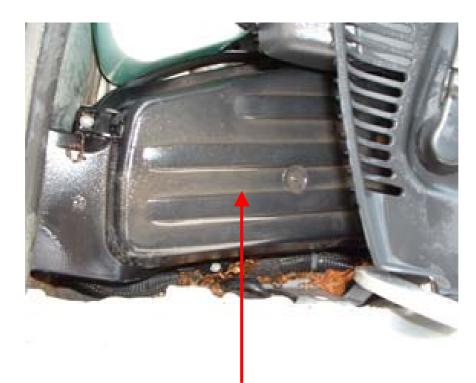
Relay box cover

If, on this vehicle water gets into the left front foot well, a possible cause could be a loose cover of the relay box. To rectify the problem the screws of the relay box cover must be tighten.
