BULLETIN

Opel Insignia Model year: 2008 - 2013 Engine: 2.0 CDTI

Loss of coolant/EGR radiator

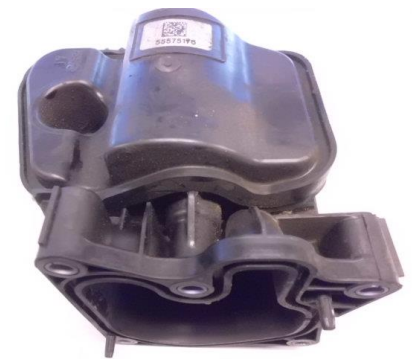
Figure 1

The above vehicles may experience a slow coolant loss due to a defective exhaust gas recirculation (EGR) radiator housing.

In case of coolant loss, the AGR radiator housing (Figure 1) should be examined closely. A crack is sufficient to allow a small amount of coolant to leak out. Due to its installation position, the AGR radiator is difficult to get to. To replace the component, proceed as follows:
