Bulletin

Opel Insignia Model year: from 2008 onwards Engine: 2.0 CDTI

Loss of engine power, Report registered in combination instrument

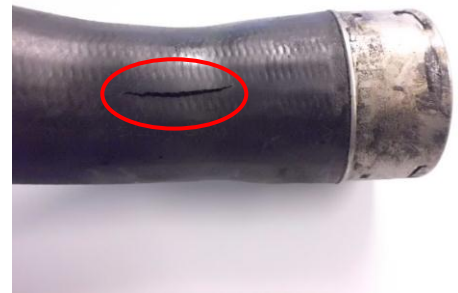
With the above-mentioned vehicle, it is possible that a crack (see picture) in the charger intake hose brings about the posting of the error message, "Service Vehicle Soon." This error message is usually given in conjunction with a sudden loss of engine power. In some cases the engine warning light also comes on in the combination instrument. When this is the case, Code P0299 (air intake pressure too low) and/or Code P2282 (incorrect air intake pressure) can be seen filed in the error memory .

The following steps should be taken to rectify the problem:

- Read error memory
- Carry out visual inspection of the air intake routing
- Replace any defective component
- Erase error / fault code memory
- Test drive vehicle to check performance
