BULLETIN

Opel Meriva B Model year: 2011 Engine: A17DT / A17DTC / A17DTS

Air intake temperature too high / Error message code 84 / Reduced engine power

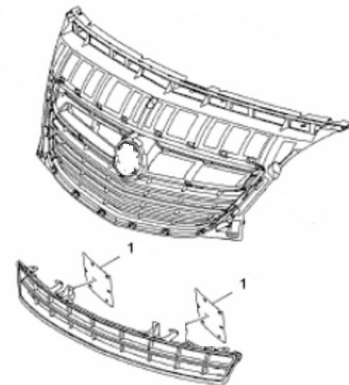
Cooling of the intercooler is impaired due to incorrect radiator grille covers. The airstream from driving cannot cool the intercooler sufficiently.

To remedy this, the radiator grille covers (drawing, item 1) should be unclipped from outside through the opening in the lower radiator grille and removed.
