BULLETIN

Peugeot 307 HDI Engine code: 9HZ (DV6TED4) Model year: 2004 - 2005

Poor acceleration performance
Noise in the vicinity of the splash wall
Engine control lamp lights up sporadically
Fault code: P0100, P3008

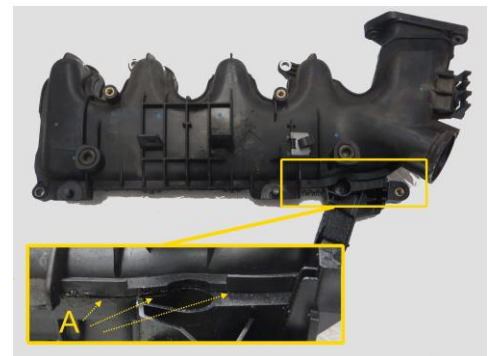
If the vehicle listed above demonstrates poor acceleration performance in conjunction with flapping noises in the vicinity of the splash wall, this may be caused by a defective intake manifold.

The intake manifold consists of two plastic housing halves bonded together. A leaky bonded joint (A) causes air to escape as boost pressure increases, while also making a distinctive noise. Depending on the size of the leak, the following fault entries may occur in the engine control unit.

P0100 - Air-mass sensor malfunction

P3008 - Air flow too strong

If a leak is detected, the intake manifold must be completely replaced. It cannot be repaired. Replacing the intake manifold requires removing the high-pressure fuel lines for the injection valves (injectors).

In order to avoid leaks later, carefully remove and re-install the lines.

Carry out an extensive test drive!
