Bulletin

Porsche Model series 911 Type 964, 933, 996

Uneven abrasion and increased wear on disc brake pads. More difficult brake pad installation.

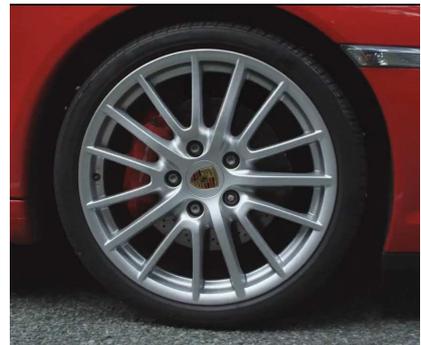
If the brake pads on the front or rear axle can only be inserted with great difficulty on the vehicle models listed above, then this may be caused by a brake calliper guide plate deformed by creeping corrosion and dirt. This dirt leads to the brake pads seizing in the guides, thereby resulting in high wear, uneven abrasion, squealing and increased temperatures on the wheel brakes.

- Properly clean the brake calliper, remove and clean the guide plates if necessary.
- Check the guide plates for damage and replace them if necessary.
- Clean and grease the contact surfaces of the guide plates.

We recommend using Hella PAGID metal-free permanent lubricant for this.
