Renault Laguna II (B74 | BG0)

Compressor does not switch on/ Fault code "too little pressure"

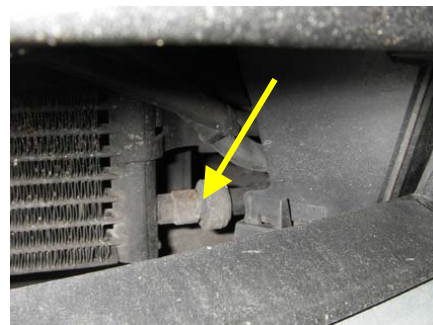
If the compressor on the above-mentioned vehicles no longer switches on despite sufficient refrigerant pressure being available, this can be caused by oxidised connections on the pressure switch.

Often, the fault memory indicates too little pressure in the refrigerant circuit, in which case the compressor is switched off. If the pressure at the low-pressure service connection on the accumulator is measured, however, it may be found that the pressure should actually be sufficient to activate the compressor. Closer examination of the pressure switch, which is usually on the left of the condenser (in the direction of travel) (see photo), reveals that the electrical connections are oxidised. This is the cause of the problem. In the case of this vehicle, the pressure switch can be replaced without the refrigerant having to be drained from the system. There is a valve beneath the switch which closes automatically when the switch is screwed off.

Behr Hella Service supplies a special adapter for this, under the part no.: 8PE 351 216-261.
