Renault Megane I **Model year: 1996 – 2002** **With air conditioning system**

Noises in recirculation mode

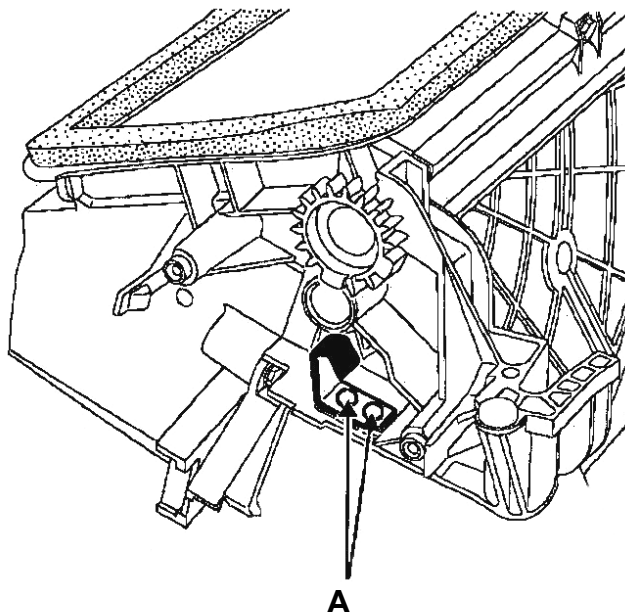
Drawing 1

If with these above-mentioned vehicles noises occur in the dashboard area in recirculation mode, the cause could be damaged teeth on the drive pinion of the recirculation flap. A break in the mechanical stop can damage the teeth on the drive pinion. To eliminate the problem, the recirculation flap and drive pinion have to be replaced.

In addition, a new mechanical stop has to be self-made from a metal plate 2 mm thick and 10 mm wide (see drawing 1). The mechanical stop is attached to the housing of the recirculation flap using two rivets (drawing 2). There is quite a considerable amount of work involved, exactly how much depends on the engine version.
