Saab 9-3 all models with manual air conditioning

Stiff heating regulation.

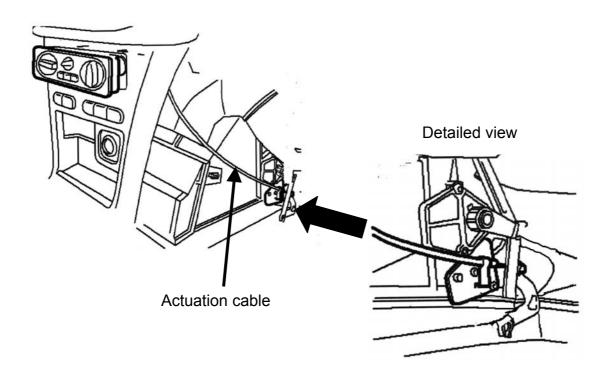
If there are complaints with these vehicles that the heating regulation is stiff, one possible cause could be a damaged actuation cable on the heating flap. A stiff heating flap can cause the actuation cable to become kinked or tear. To eliminate the fault the actuation cable has to be replaced and the heating flap checked for perfect function.

When the new actuation cable has been mounted, turn the temperature regulator to cold/hot to check whether the respective final position of the heating flap is reached.
