Bulletin

Saab

9-3

Loss of coolant

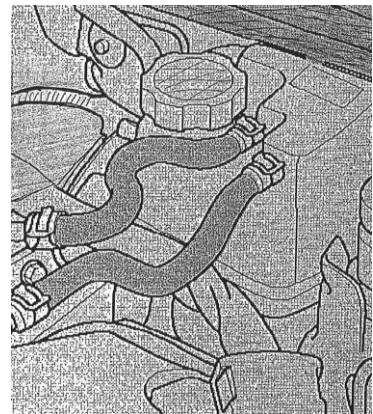
Figure 1
(Old layout)

In the case of the above-mentioned vehicles, problems can arise because of loss of coolant. The cause of this can either be a defective coolant expansion tank or damaged engine coolant hoses on the coolant expansion tank. The positioning of these components (Figure 1) is located very close to the turbo charger, which means that material fatigue can result because of the hot ambient temperature.

In order to remedy this, the coolant expansion tank is to be replaced and the hoses of the coolant expansion tank are also to be replaced / repositioned.
