## **Smart** **All models with petrol engine** **Type 160.910 (33, 40, 45 KW)**

### **Loss of engine power.**

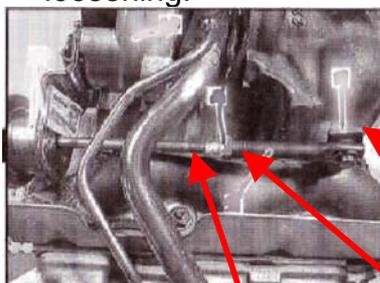
If there are complaints of a loss of engine power in the case of vehicle models with the above-mentioned engine type, one possible cause is insufficient boost pressure. This fault is caused by an incorrect length setting of the connecting rod between the diaphragm cell of the boost pressure control valve and the control rod. Due to a loosened conternut on the connecting rod, the length changes, and the movements of the diaphragm cell are no longer transmitted correctly. In order to eliminate the fault, the length must be set correctly.

- Remove the vacuum control line on the diaphragm cell, and connect a hand vacuum pump.
- With the aid of a magnet, fasten a dial gauge to the exhaust manifold in such a way that the movements of the control rod can be measured.
- Subject the diaphragm cell to a vacuum of 510–550 mbar.
- The control rod should have moved by 1 mm. If this is not the case, the connecting rod must be set by twisting. After this, tighten the conternut and use locking paint to protect it against renewed, unwanted loosening.
