Volvo

V70 up to vehicle ident. no.: 549452

S70 up to vehicle ident. no.: 571822

Moisture in the front indicators

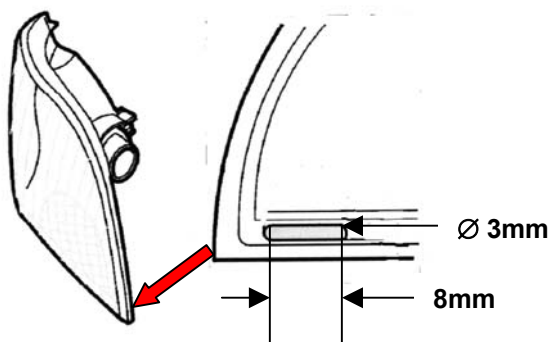
In the case of these vehicles, it is possible that in wet and damp weather, water could penetrate the front indicators. In this case, the indicators do not have to be replaced. By making a ventilation opening an effective remedy can be achieved. To make the ventilation opening proceed as follows:

- Remove the indicators by pressing the retaining clips down.
- Remove the bulb socket.
- In the lower, rear area (see drawing), drill several holes to a length of 8 mm with a 3 mm drill, to produce a large elongated hole.
- **Caution: Drill through the indicator housing carefully, so that when puncturing the surface the indicator lens is not damaged.**
- Refit the indicators and carry out a functional test.
