## **Volvo S 40 / V 40 model year 1998/99 / 2000 with petrol engine**

### **Ticking noises from engine bay.**

Bulletin

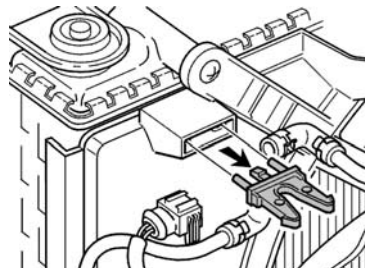
Picture 1

On this vehicle, it is possible to hear ticking noises from the engine bay, produced by the solenoid valve of the absorption canister. To solve the problem, a revised bracket for the solenoid valve must be installed. For that consider the following steps:

- Remove the hoses and the connector from the solenoid valve (fitted on the left side of the fan cover).
- Remove the solenoid valve from the bracket (Pic.1).
- Remove the bracket from the fan cover and dispose of it (Pic.2).
- Fit the new bracket, with the rubber insulation, to the solenoid valve (Pic3).
- Screw the solenoid valve with the bracket to the fan cover (use the right hole of the old bracket Pic.4).
- Refit the hoses and connector to the solenoid valve.
- Check for function and leaks.
