Volvo XC90 Model year: 2003 - 2004 Up to VIN: 079857

Cold air stream in the footwell

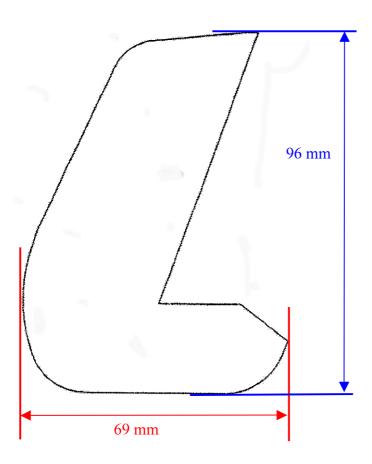
Template for ventilation louvre (scale 1:1)

With the above-mentioned vehicles there can be a very cold air stream in the driver footwell when the air-conditioning is switched on. This occurs particularly when high outdoor temperatures are prevailing. In this case, a thin, L-shaped piece of foam should be glued to the back of the footwell air vents.

- Remove the ventilation louvre in the driver's footwell
- Cut out the template (scale 1:1) and transfer the dimensions onto the foam
- Cut out the foam and use double-sided adhesive tape to stick it to the back of the ventilation louvre in such a way that the air flow opening is reduced by approx. 1/3
- Mount the ventilation louvre again
