VW

Noises out of the steering column.

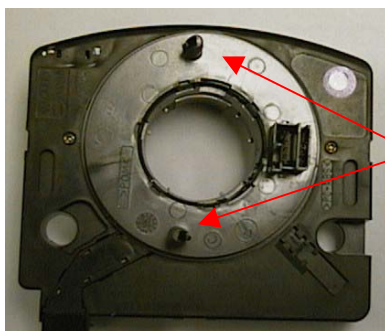
Picture 3

If dragging or clicking noises are heard from the steering column, a possible cause could be a too small or too large a gap between the return ring assembly (picture 3) and the steering wheel. If the gap is too small, the return ring is dragging along the steering wheel. If the gap is too big, the clips are loose and not locked into the steering column.

To eliminate the noise, the gap must be readjusted. To do this consider the following steps:
