VW

Failure of the pressure sensor

Bulletin

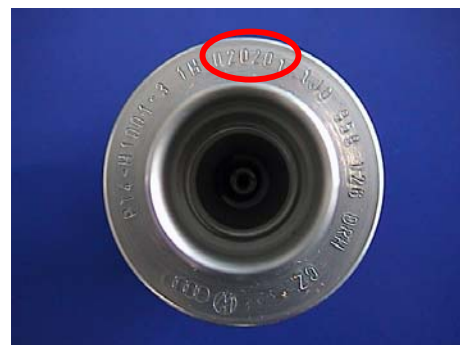
A permanent on/off- switching of the air-conditioning system can be caused by a faulty pressure sensor (not pressure switch). For example, water admission among others can lead to a malfunction of the sensor. This concerns particularly sensors before the production date: January 2000 .

The production date on the pressure sensor is indicated by a six-digit code number (see picture: 020201=02.02.2001).
