VW

Golf / Golf Estate

Starting from model year 1997

Excessive engine temperature

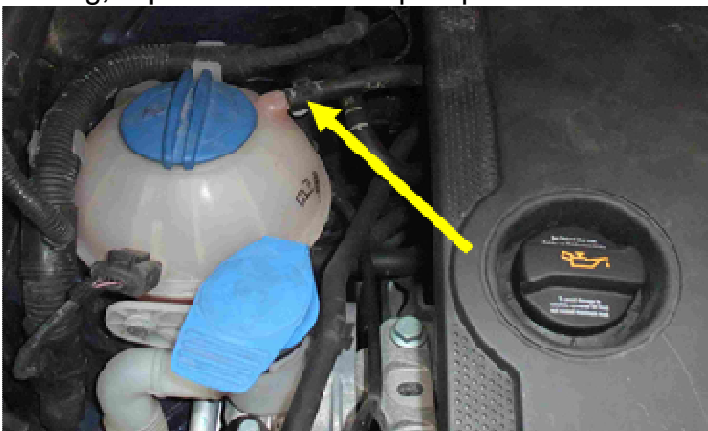
The problem may be caused by a broken paddle wheel in the coolant pump.

Additionally, remove the coolant return line from the coolant expansion tank (see figure below). If the coolant is not flowing, replace the coolant pump.
