VW Golf 3 (1H)

Instrument cluster / Switch rear window heating: implausible functions

Bulletin

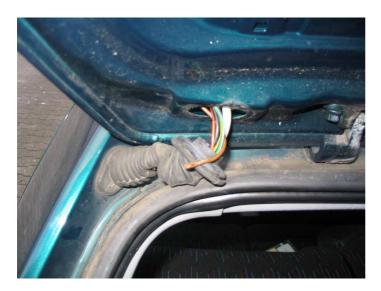
The lighting on the instrument cluster switches on, for example, when the rear window heating is actuated. On the other hand, the control lamp for the rear window heating switch lights up when the lighting is switched on.

This can be caused by a cable break in the cable feed through the tailgate (photo). If removal of the cable feed shows that the cable is broken or the insulation damaged, professional repairs can restore the correct lighting function again.
