Bulletin

VW Golf V 1.9D TDI PD Engine code: BKC

Poor engine starting performance. Engine is operating in emergency mode.

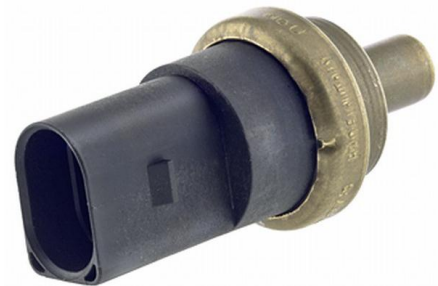
Figure 1.

If the fault pattern listed above is reported, the cause may be a defective coolant temperature sensor. In addition, error codes (triggered by implausible sensor values) may be stored in the engine control unit.

In addition, with the potentially misleading turbocharger pressure error code (P1556), excessive engine knocking while idling could be indicative of a faulty sensor.

- Disconnect wire harness multi-plug from the engine control unit and the coolant temperature sensor and perform a continuity test.
- Check the contacts on both sides for corrosion and mechanical damage and repair them if necessary.
- Check the ground connections.
- Check that coolant temperature sensor is functioning properly. As guidelines, the specified resistance value should be $\approx 2080 \Omega$ at 25°C and $\approx 289 \Omega$ at 85°C respectively.

Replace the sensor if necessary (see Figure 1.).

Hella coolant temperature sensor: 6PT009309-331

Then clear the entries present in the error memory.
