VW Lupo **All vehicles with manual air** **conditioning up to model year 02.2000**

Air conditioning occasionally does not work

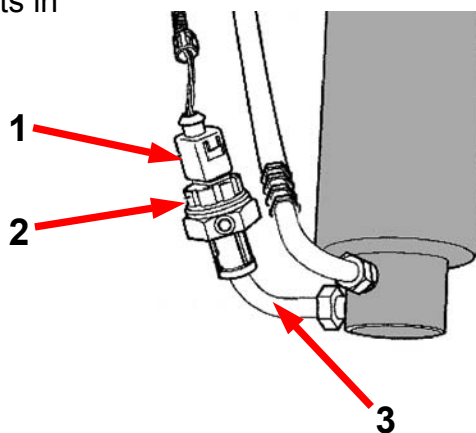
If there are complaints about the above-mentioned fault, the cause could be a defective pressure switch. Under certain operating conditions of the air conditioning system, the defective pressure switch switches the system off occasionally. In this case, the pressure switch, in the high-pressure circuit, must be replaced. The pressure switch can be removed without having to recover the refrigerant.

- Remove the bumper trim. The pressure switch, on the filter-dryer, is located on the right, behind the trim.
- Remove the plug connection (1).
- Hold the refrigerant line (3) steady when unscrewing the pressure switch (2).
- Replace the sealing ring, and screw the new pressure switch (Behr-Hella no.: 6ZL 351 028-221) on tight to a torque of 8 Nm.
- Refit removed parts in reverse order.
